**ANIMAL VEHICLE CRASH
MITIGATION USING
ADVANCED TECHNOLOGY
PHASE I: REVIEW, DESIGN AND
IMPLEMENTATION**

Final Report

SPR-3(076)

August 2006

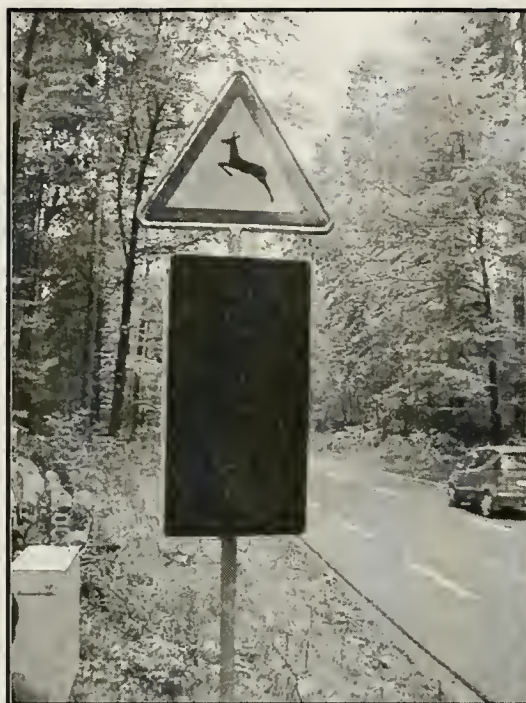
Figure 4.3: Warning signs with 40 km/h (25 mi/h) speed limit at a location in Switzerland (Photo: Mary Gray/FHWA).

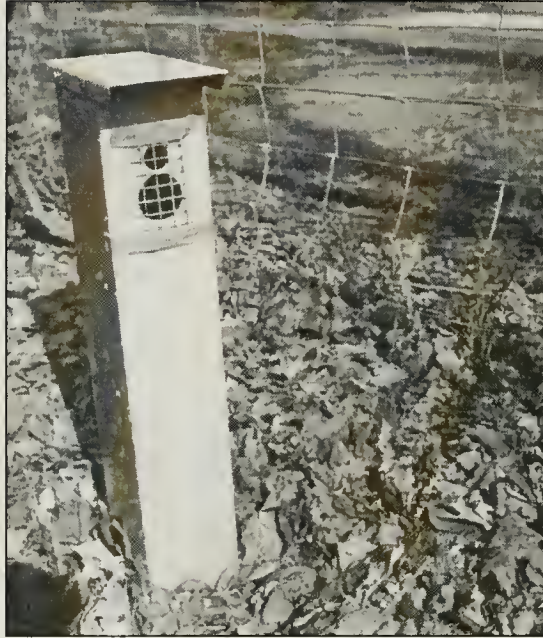
Figure 4.10: Cabinet with infrared sensor in Ugchelen, The Netherlands.
The wire in front of the two openings prevents birds from nesting in the box. (Photo: Marcel Huijser/WTI-MSU).

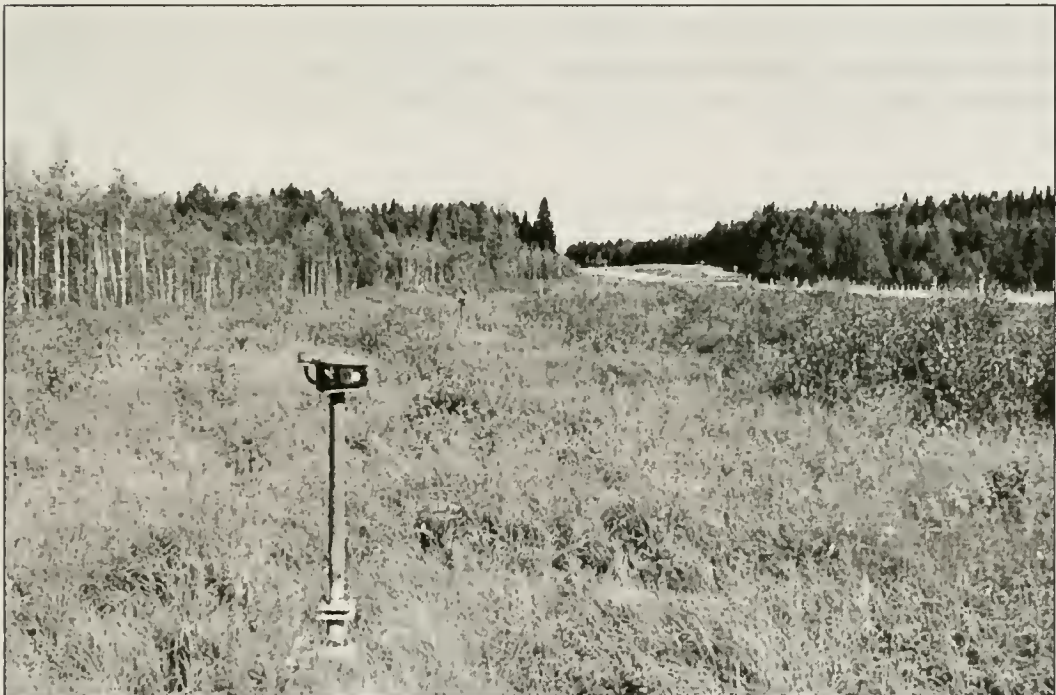
Figure 4.12: The posts holding the lights in Rosvik, Sweden (Photo: Andreas Seiler).

In 1999 an animal detection system was installed along highway E4 near Rosvik in northern Sweden, between Piteå and Luleå (Figures 4.11-4.13) (Andreas Seiler, Grimsö Wildlife Research Station, Department of Conservation Biology, Swedish University of Agricultural Sciences, personal communication; Kjell Ståhl, Road Administration, Luleå, personal communication). The system was designed by PIK AB, Karlskrona, Sweden, and installed by the manufacturer and the Road Administration. The system operates on a break-the-beam principle with infrared light.

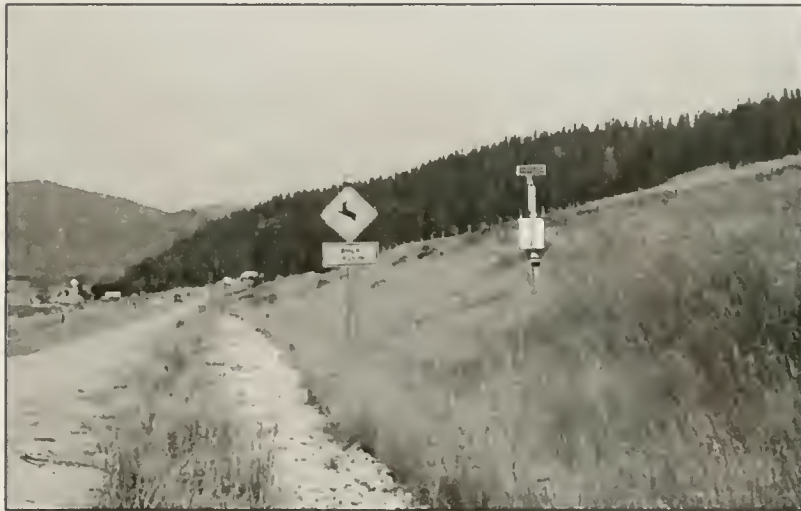
Figure 4.14: Warning signal and sign in Colville, Washington, USA (Photo: Washington Department of Transportation, Eastern Region)

On 20 June 2000 an animal detection system was installed on Hwy 395 (mile post 290), north of Spokane, south of Colville, three miles north of Chewelah, Washington (*Shipley 2001; Robinson, et al. 2002; J. Schafer, WSDOT Research Office, personal communication; Brian Walsh, WSDOT, Traffic Safety and Operations, personal communication*). The system consisted of two lasers, one placed on each side of the road, two standard deer warning signs, two smaller rectangular signs that read “When Flashing”, and two solar powered red flashing beacons (Figure 4.14). The system was designed by an electrical engineer (subcontracted) and manufactured in-house at the WSDOT Research Office. The system was installed by the vendor and WSDOT. When the laser beam was broken the lights were switched on. The lasers operated on batteries with a one-week lifespan while the red strobes were solar powered.

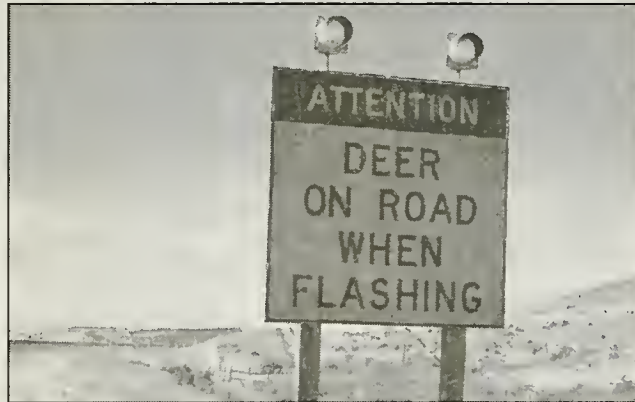
Figure 4.15: Activated warning signals and sign at Nugget Canyon, Wyoming, USA (Photo: Bill Gribble/WYDOT)

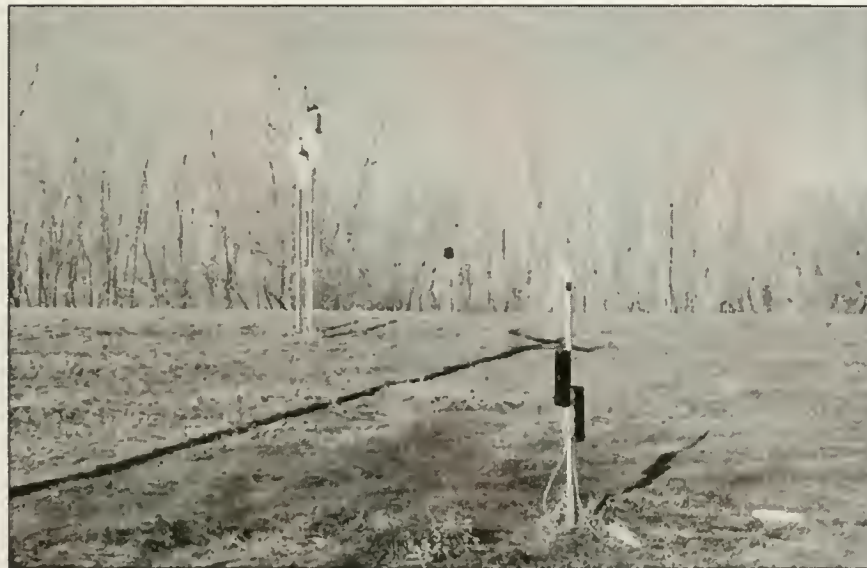
Figure 4.27: The sensors in the right-of-way in Marshall, Minnesota, USA (Photo: Robert Weinholzer, MNDOT)

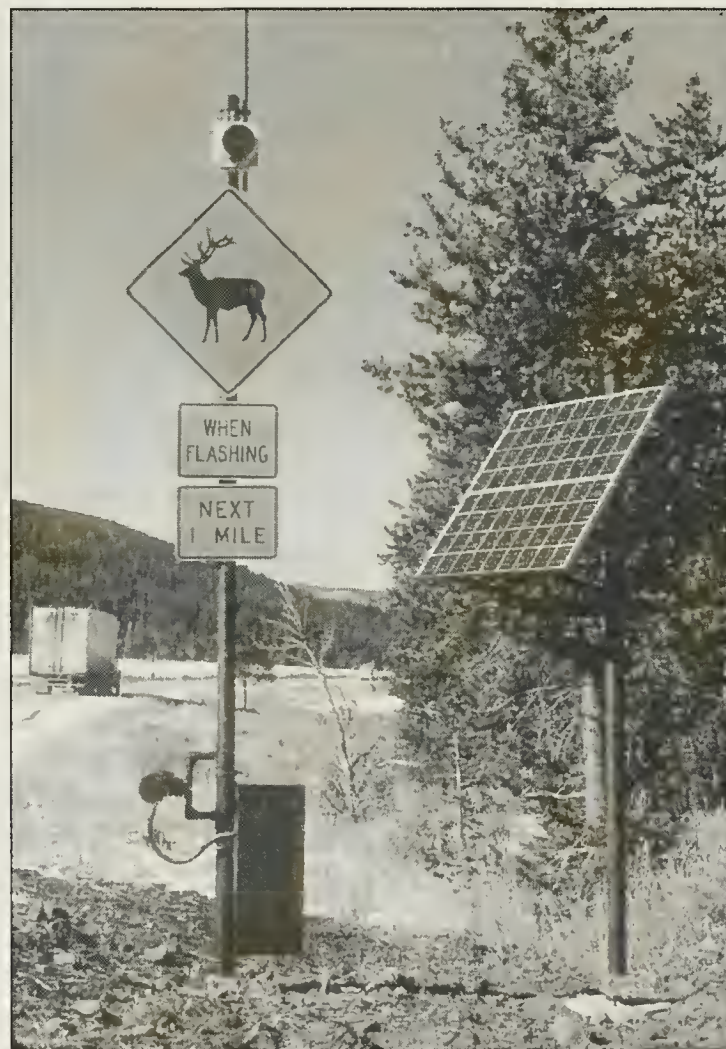
Figure 4.36: Original warning signal and sign in Yellowstone National Park, Montana, USA. A sensor is attached on the left side of the post; a cabinet with circuit boards and batteries is attached to the right side of the post. (Photo: Marcel Huijser, WTI-MSU)

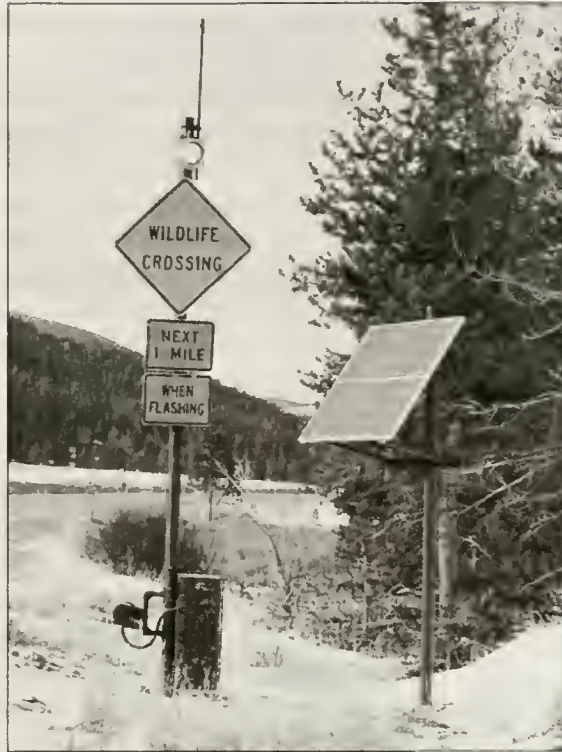
Figure 4.37: Activated warning signal and sign with new text sign “WILDLIFE CROSSING” and solar panel in Yellowstone National Park, Montana, USA (Photo: Marcel Huijser, WTI-MSU)

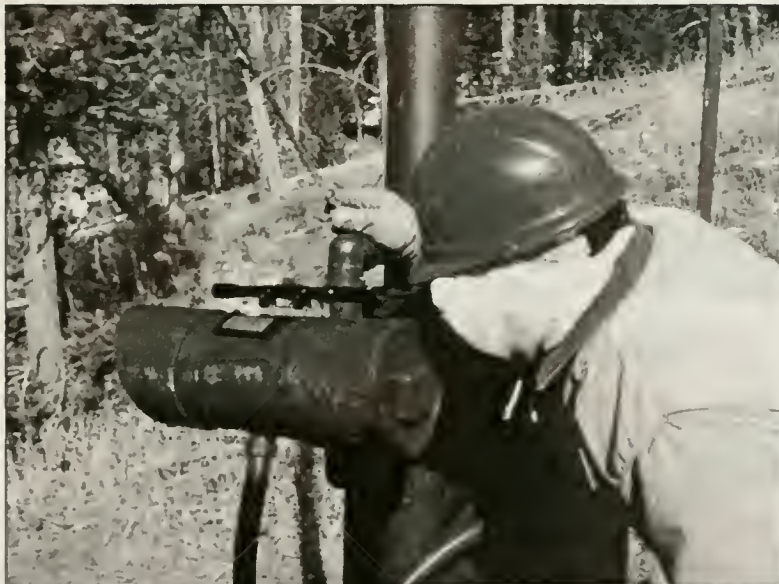
Figure 5.24: Sensors at the MT site were aligned by usnig a scope (Photo: Marcel Huijser, WTI-MSU)

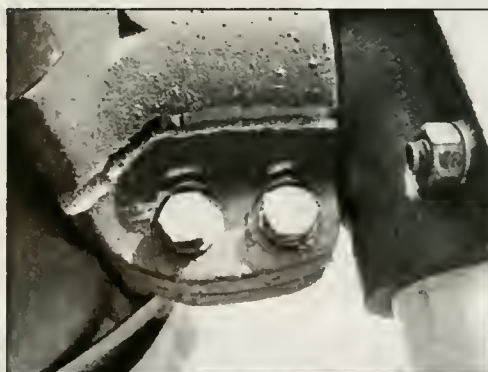
Figure 6.8: The brackets holding the sensors cracked as a result of extreme temperature fluctuations at the MT site
(Photo: Marcel Huijser, WTI-MSU)

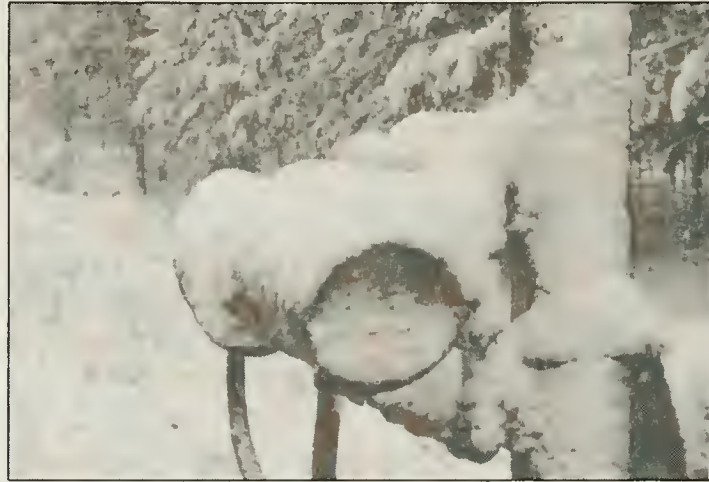
Figure 6.9: Snow and ice build-up on the sensors caused false positives at the MT site (Photo: Marcel Huijser, WTI-MSU)

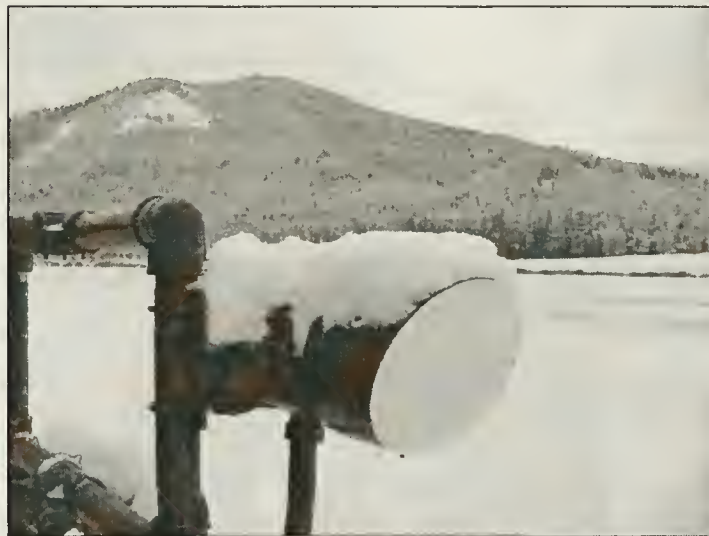
Figure 6.10: Placing a smooth surface at an angle in front of the sensors prevented snow and ice build-up on the sensors at the MT site (Photo: Marcel Huijser, WTI-MSU)

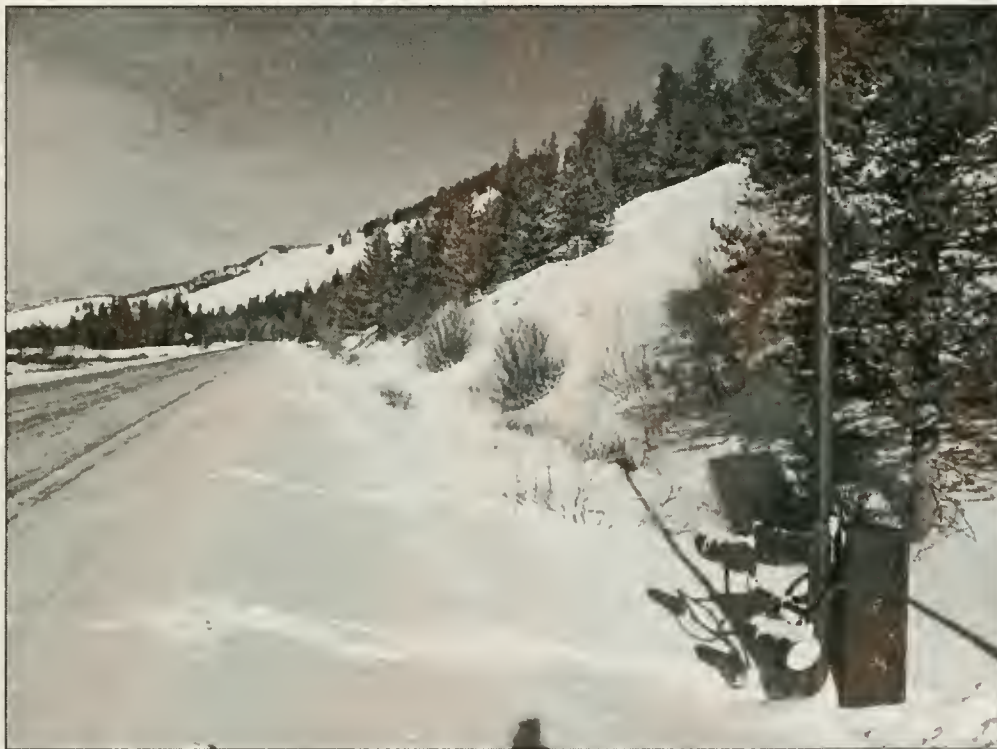
Figure 7.6: Investigation for potential blind spots. The tracks indicate where human models passed through the beam. (Photo: Marcel Huijser, WTI-MSU)

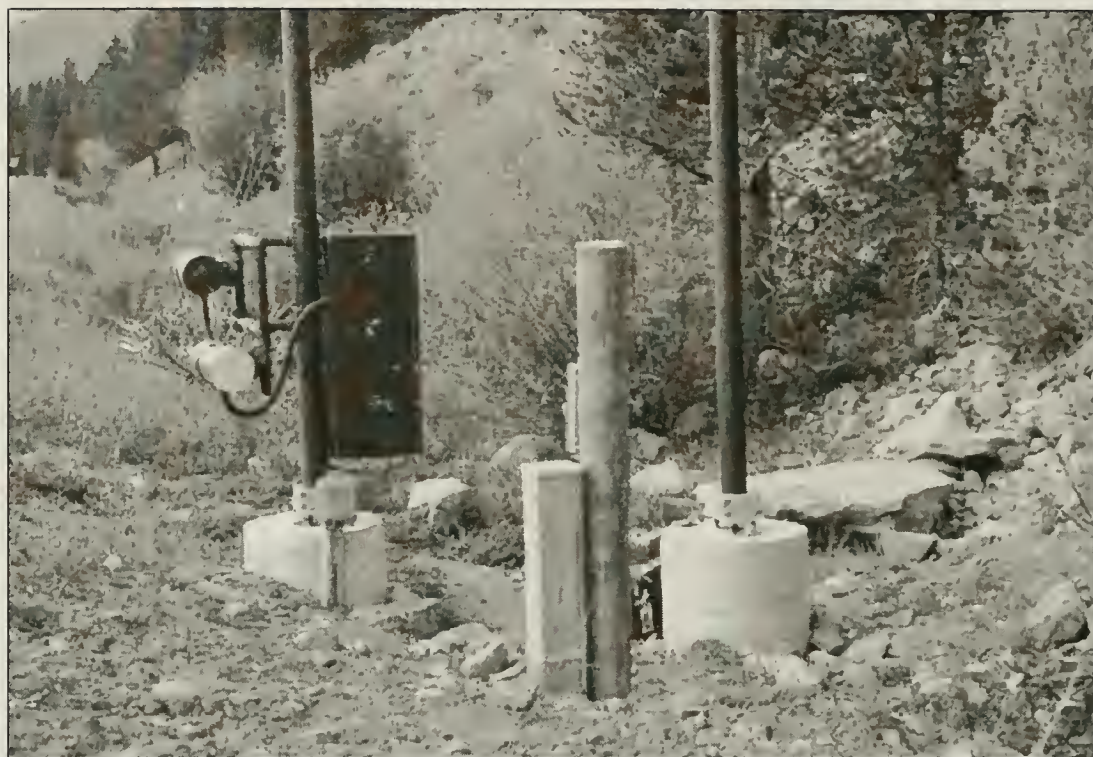
Figure 8.1: Some of the concrete foundations were in the clear zone and too high above the ground. This is the master station. The wooden post on the foreground is for the link to the land-based phone line. (Photo: Marcel Huijser, WTI-MSU)

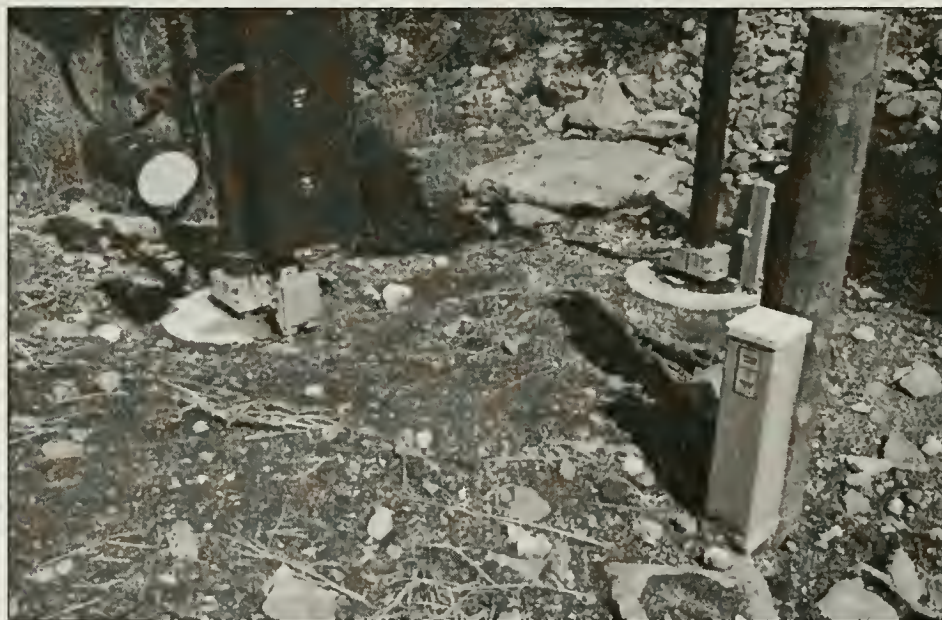
Figure 8.2: The problem with some of the concrete foundations was addressed by putting weed free soil around the posts while not blocking the drainage from the road. (Photo: Marcel Huijser, WTI-MSU)

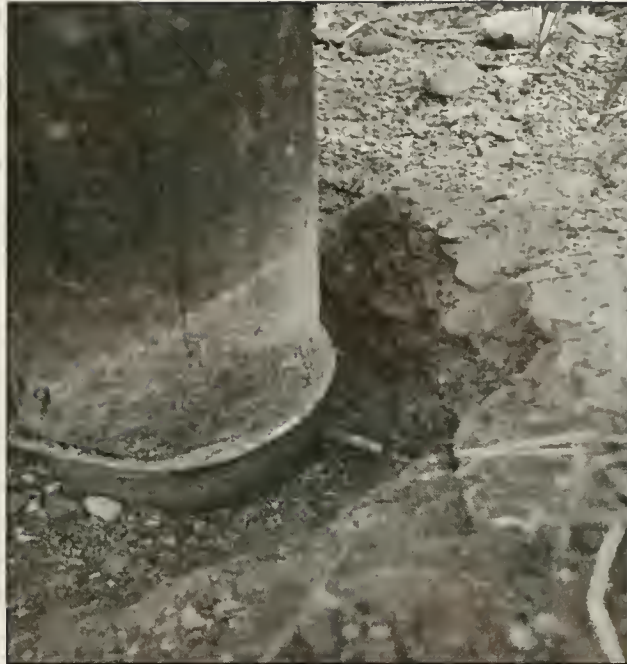
Figure 8.3: Some of the wooden poles were buried too deep. The stick indicates the upper of the three holes that serve as a break-away in case of a collision. All three holes should have been above the ground level. (Photo: Marcel Huijser, WTI-MSU)

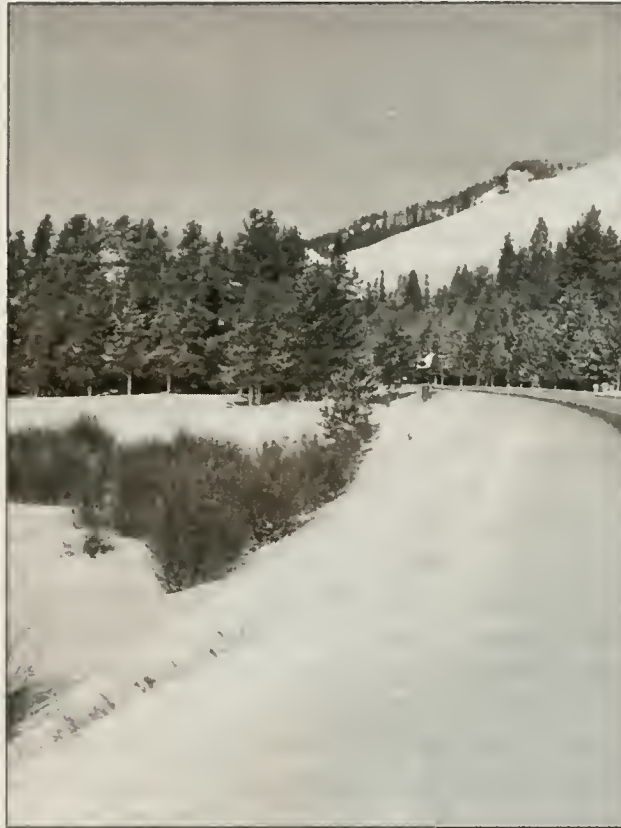
Figure 8.5: Curves and slopes caused the beam to shoot too high in some locations at the MT site, causing blind spots. Shown here is detection Zone 8 (see Figure 5.7 for exact location). (Photo: Marcel Huijser, WTI-MSU)

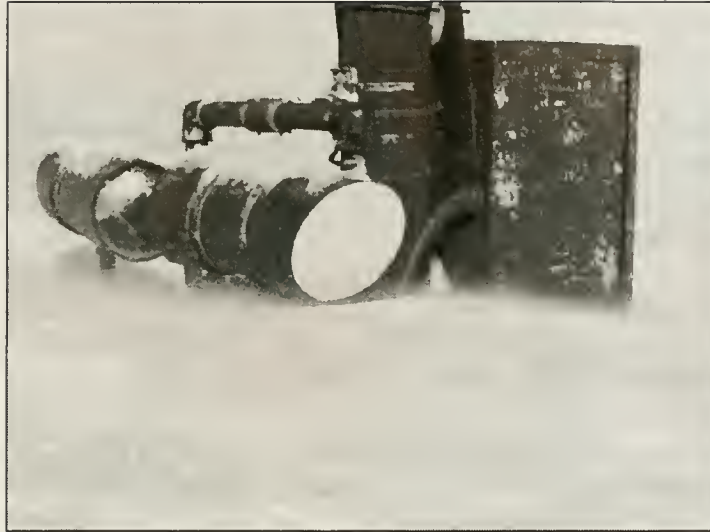
Figure 8.6: Snow accumulation at the MT site. Snow accumulation may bury the sensors, potentially causing downtime for the system. (Photo: Marcel Huijser, WTI-MSU)

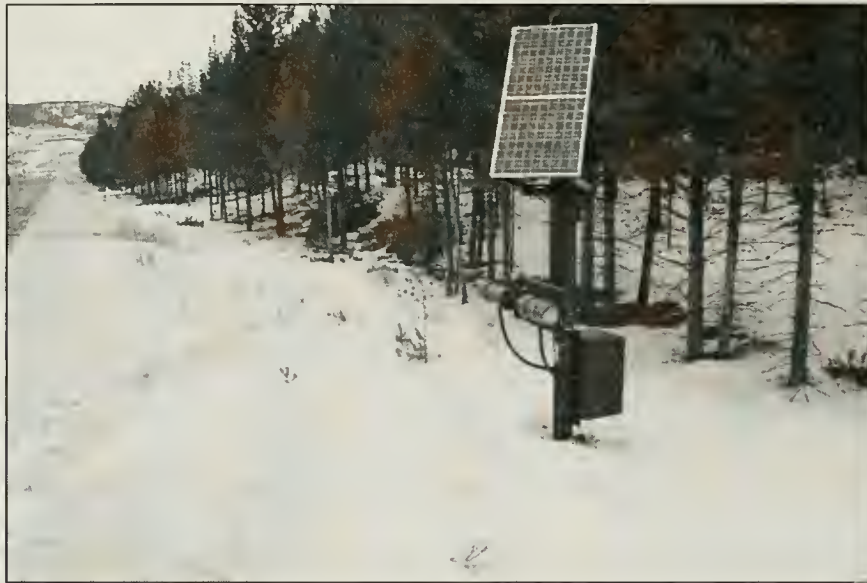
Figure 10.3: Animal detections may reduce or prevent animal-vehicle collisions, but the poles and equipment in the right-of-way form a hazard of their own. Here a car went off the road at the MT site and just missed the pole. However, the damage to one of the sensors was about \$2000. (Photo: Jason Norman, MDT)
